## SEASONAL MONITORING PROGRAM DISMANTLE REPORT SITE 533813, CAMAS, WASHINGTON.

January 1997

Suspension of SMP Site Monitoring Activities, Site 533813.

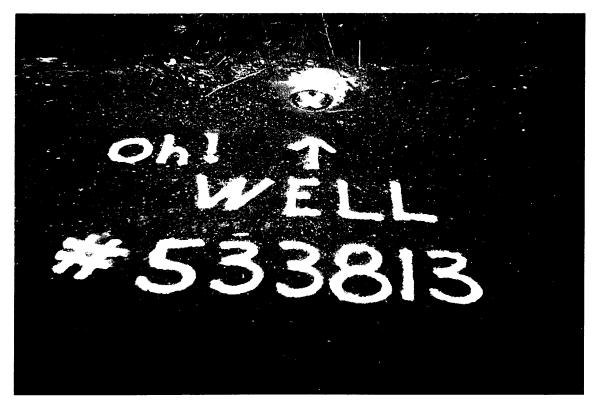
Observation Piezometer.

- The observation well and cap threads were thoroughly cleaned and lubricated (greased) before the well was sealed.
- The air temperature probe and rain gauge were disconnected from the steel pole and the pole was removed from the bottom joint. The pole stub, embedded in the ground, was cleaned and lubricated before capping.

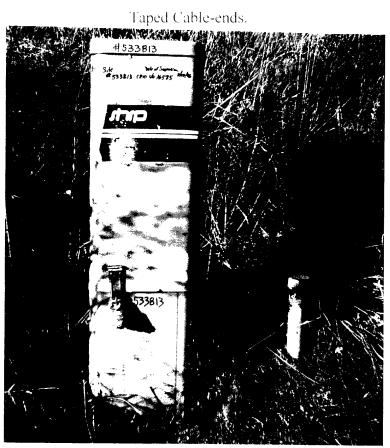
Equipment Cabinet.

- The instrument panel board containing the CR10 datalogger, the relay and the terminal strip was removed.
- The equipment cabinet was checked and adequate drainage was ensured in case of heavy precipitation.

- The equipment cabinet lock was lubricated with graphite lubricant, the lock was taped to keep out the natural elements.
- The deflection and elevation measurement locations were marked with white paint for easy identification.
